TEST REPORT FOR:

Virginia Department of Transportation
ET-Plus 50' (15.24 m) System 4" Channel

TESTED TO:
NCHRP 350
Test 3-31

TEST REPORT NUMBER:
TR-P35107-02-NC

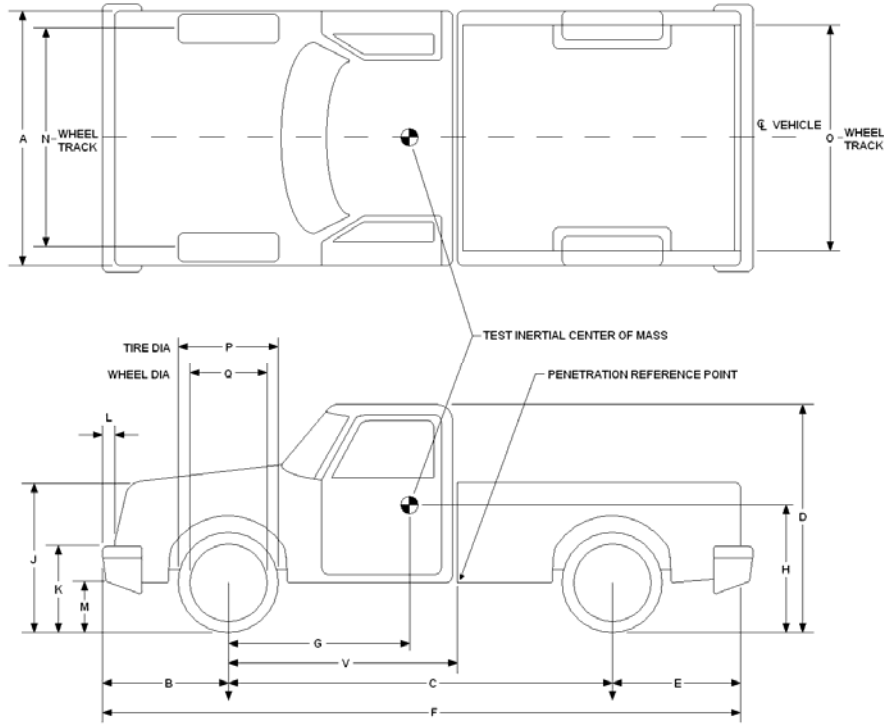
TEST VEHICLE GEOMETRY

mm	in.		mm	in.		mm	in.		mm	in.
A	1960	77.2	E	1145	45.1	J	1090	42.9	N	1750	68.9
B	990	39.0	F	5515	217.1	K	740	29.1	O	1678	66.1
C	3380	133.1	G	1306	51.4	L	90	3.5	P	740	29.1
D	1855	73.0	H	718	28.3	M	347	13.7	Q	441	17.4

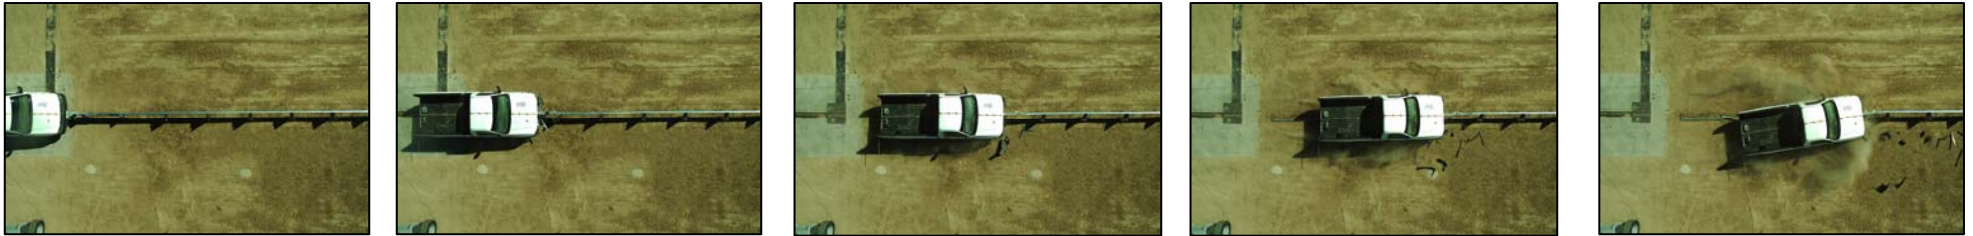
DATA SHEET 4
SUMMARY OF RESULTS

0 ms 250 ms 500 ms 750 ms 1000 ms

GENERAL INFORMATION		OCCUPANT RISK VALUES	
TEST AGENCY	KARCO Engineering, LLC.	FLAIL SPACE VELOCITY (m/s)	
TEST NO.	3-31	X DIRECTION	6.9
DATE	9/17/2015	Y DIRECTION	0.6
TEST ARTICLE		THIV (Optional) (m/s)	7.0
TYPE	Terminal	RIDEDOWN ACCELERATION (g)	
END TREATMENT LENGTH ¹	15.3 m (50.0 ft.)	X DIRECTION	-10.8
ADJOINING BARRIER LENGTH ²	34.2 m (112.3 ft.)	Y DIRECTION	-4.5
TEST VEHICLE		PHD (Optional) (g)	10.8
TYPE	Production Model	ASI (Optional)	0.59
DESIGNATION	2000P	VEHICLE DAMAGE	
MODEL	2004 Chevrolet Silverado 2500	EXTERIOR	
MASS (CURB)	2199.0 kg (4847.9 lbs)	VDS	12-FC-5
MASS (TEST INERTIAL)	2026.0 kg (4466.5 lbs)	CDC	12FCEW2
DUMMY MASS		INTERIOR	
MASS (GROSS STATIC)	2026.0 kg (4466.5 lbs)	OCDI	FS0000000
IMPACT CONDITIONS		POST-IMPACT VEHICULAR BEHAVIOR	
VELOCITY (km/h)	101.32 km/h (62.96 mph)	MAXIMUM ROLL ANGLE (°)	-5.5 ³
ANGLE (°)	90.4	MAXIMUM PITCH ANGLE (°)	3.5 ³
IMPACT SEVERITY (kJ)	802.4	MAXIMUM YAW ANGLE (°)	-10.3 ³

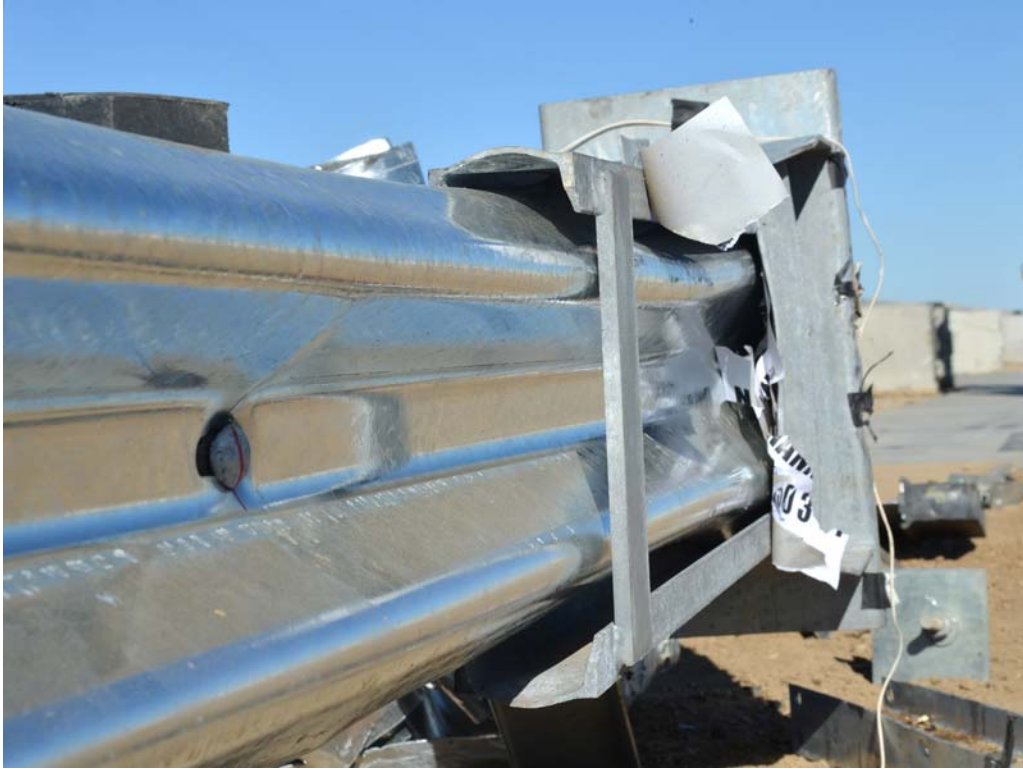
FIGURE 35. Test Article Damage

The test vehicle impacted the ET-Plus 50' (15.24 m) System at a velocity of 101.32 km/h (62.96 mph). The test vehicle impacted the ET-Plus extruder head and pushed it down the guardrail. The HBA top post broke away from the bottom post and remained attached to the extruder head until it impacted the first SYTP post. The first four (4) SYTP posts were directly impacted by the vehicle and yielded at ground level and detached from the rail. The vehicle and the extruder head stopped shy of the fifth SYTP post and the vehicle rebounded backward and toward the passenger side. The test vehicle came to rest approximately 8.9 m (29.3 ft.) forward and 0.5 m (1.5 ft.) right of its position at the point of impact. An overhead illustration of the test vehicle and test article in their pre-test and post-test conditions is shown in Figure 62 in Appendix D. Sequential photographs of the test sequence are shown on Data Sheet 4. The vehicle sustained damage to the front end as a result of the impact with the ET-Plus 50' (15.24 m) System. The bumper and grill were pushed rearward into the engine compartment. The occupant compartment was not penetrated as a result of the impact.

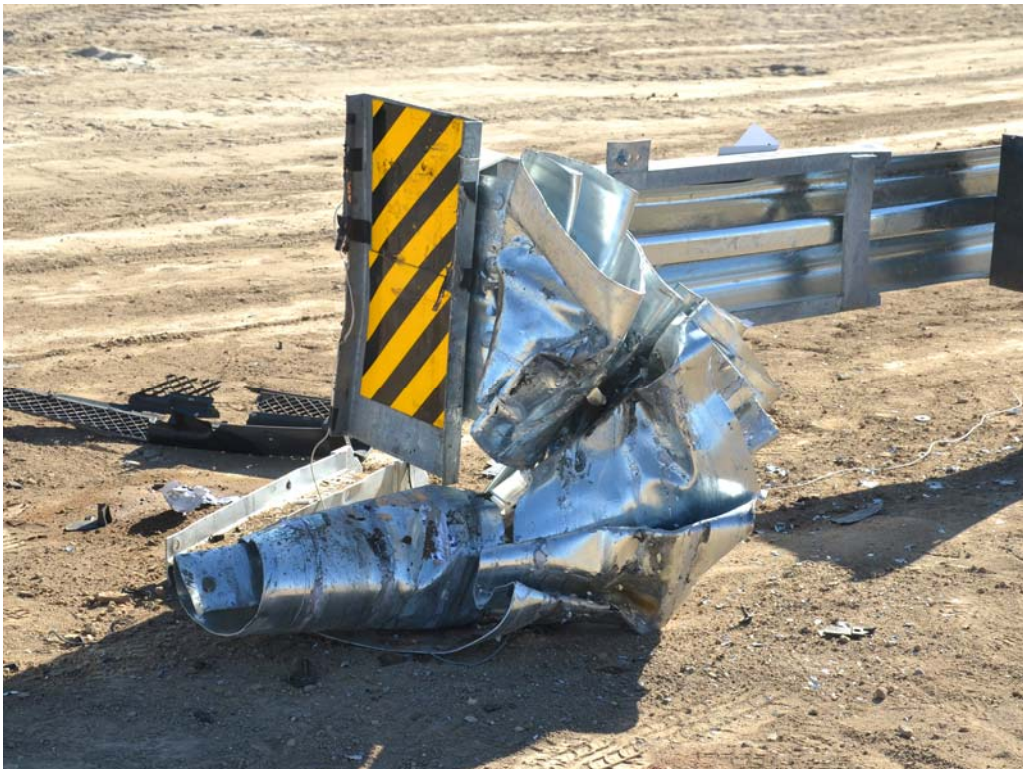
FIGURE 36. Test Article Damage

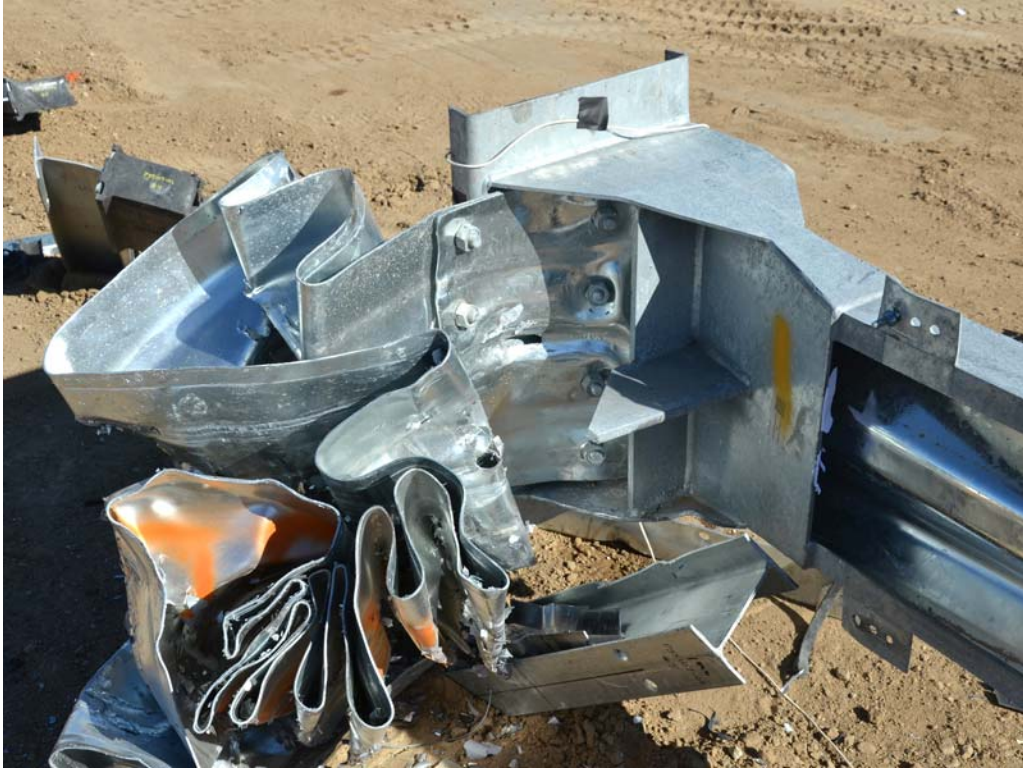
FIGURE 37. Test Article Damage

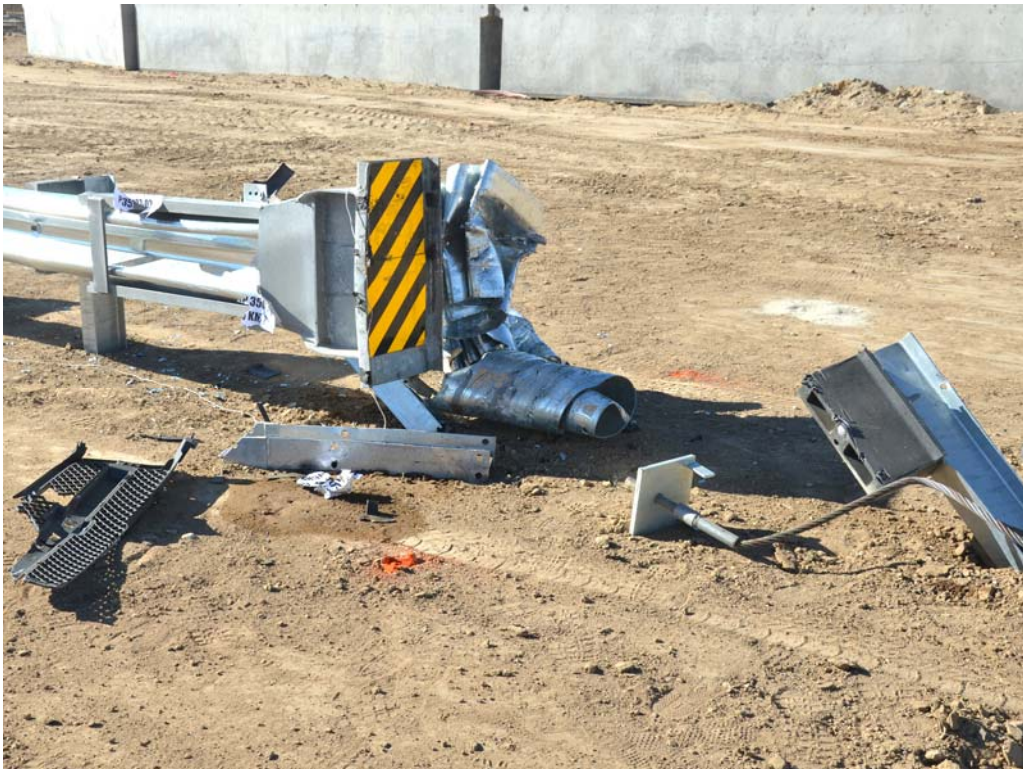
FIGURE 38. Test Article Damage

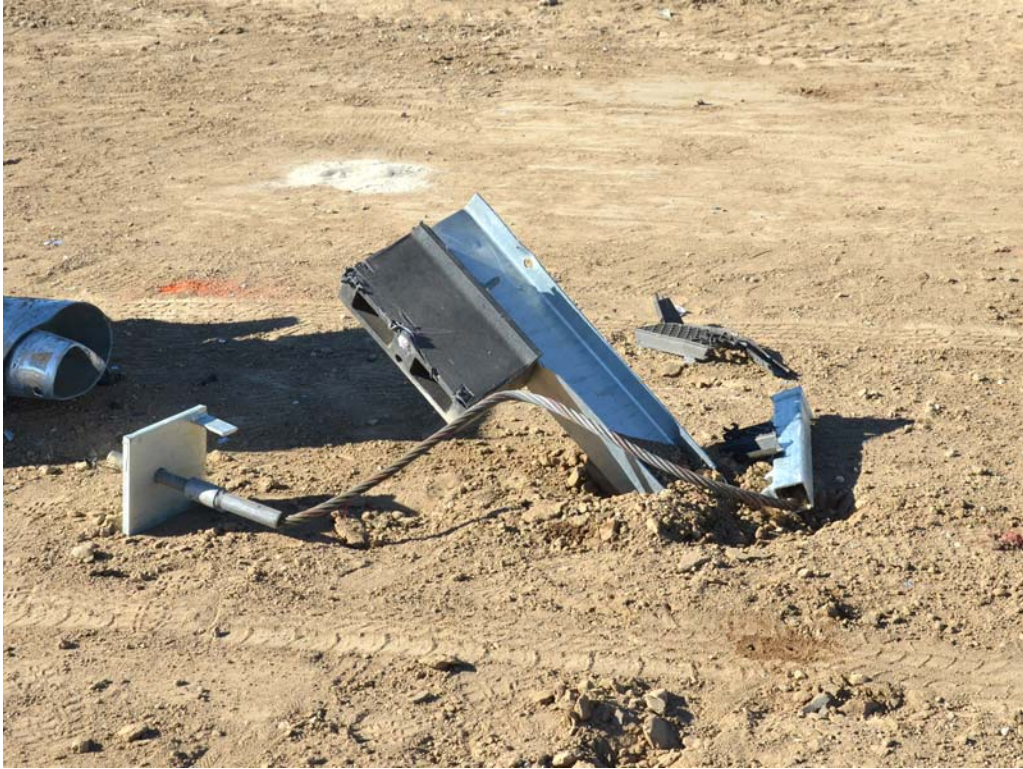
FIGURE 39. Test Article Damage

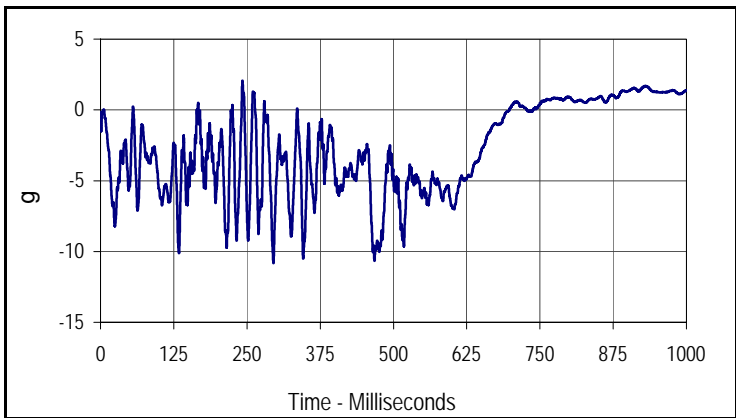
Curve Description			
Test Vehicle CG X Moving Average			
Plot No.	Type	SAE Class	Units
002	AVG	180	g
Max	Time	Min	Time
2.1	242.2	-10.8	295.1

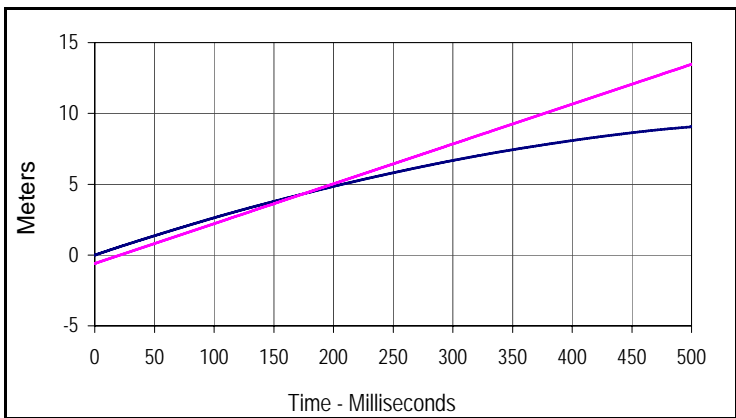
Curve Description			
Test Vehicle CG X Displacement			
Plot No.	Type	SAE Class	Units
004	IN2	180	Meters
Max	Time	Min	Time
9.5	622.4	0.0	0.0

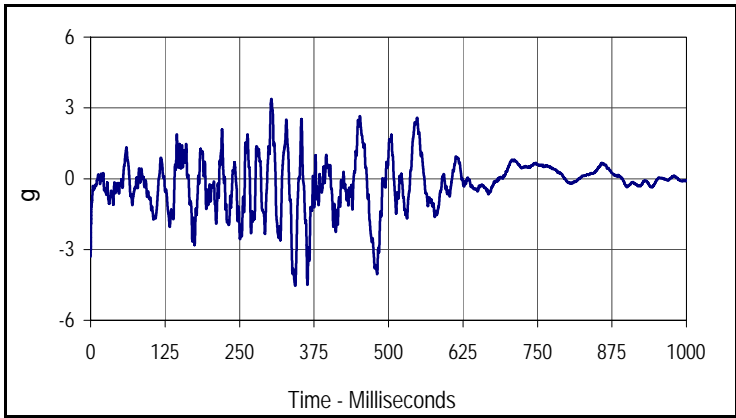
Curve Description			
Test Vehicle CG Y Moving Average			
Plot No.	Type	SAE Class	Units
006	AVG	180	g
Max	Time	Min	Time
3.4	303.6	-4.5	343.4

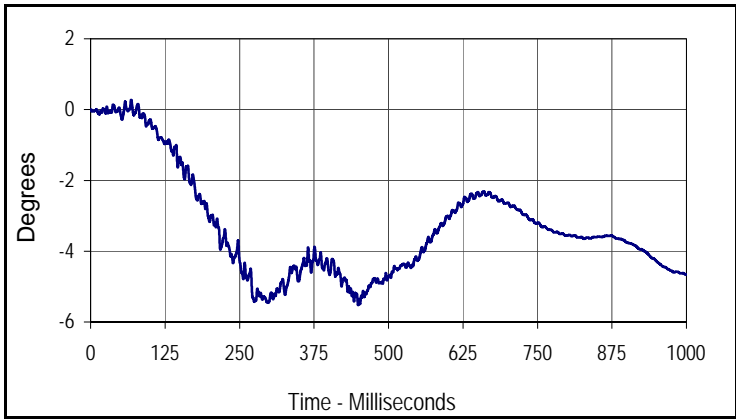
Curve Description			
Test Vehicle Roll Angle			
Plot No.	Type	SAE Class	Units
011	IN1	180	Degrees
Max	Time	Min	Time
0.3	68.2	-5.5	449.0

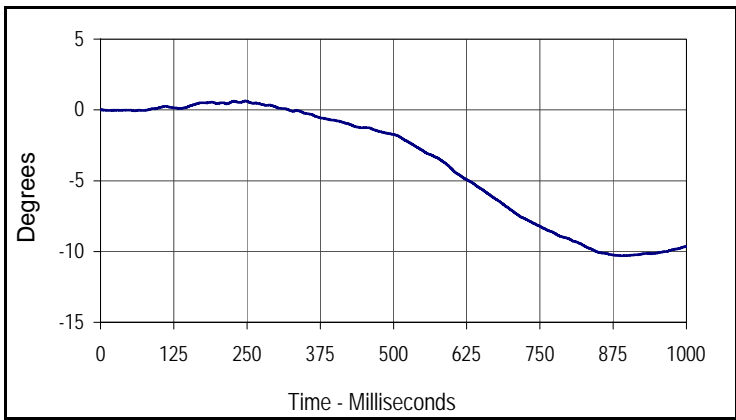
Curve Description			
Test Vehicle Yaw Angle			
Plot No.	Type	SAE Class	Units
012	IN1	180	Degrees
Max	Time	Min	Time
0.6	247.7	-10.3	895.8

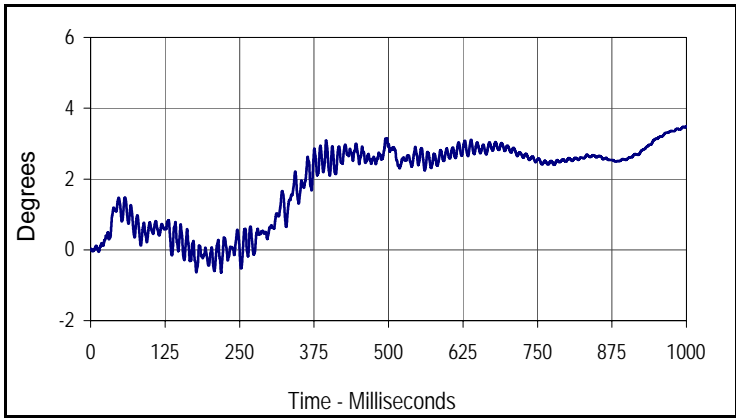
Curve Description			
Test Vehicle Pitch Angle			
Plot No.	Type	SAE Class	Units
013	IN1	180	Degrees
Max	Time	Min	Time
3.5	999.9	-0.6	219.0

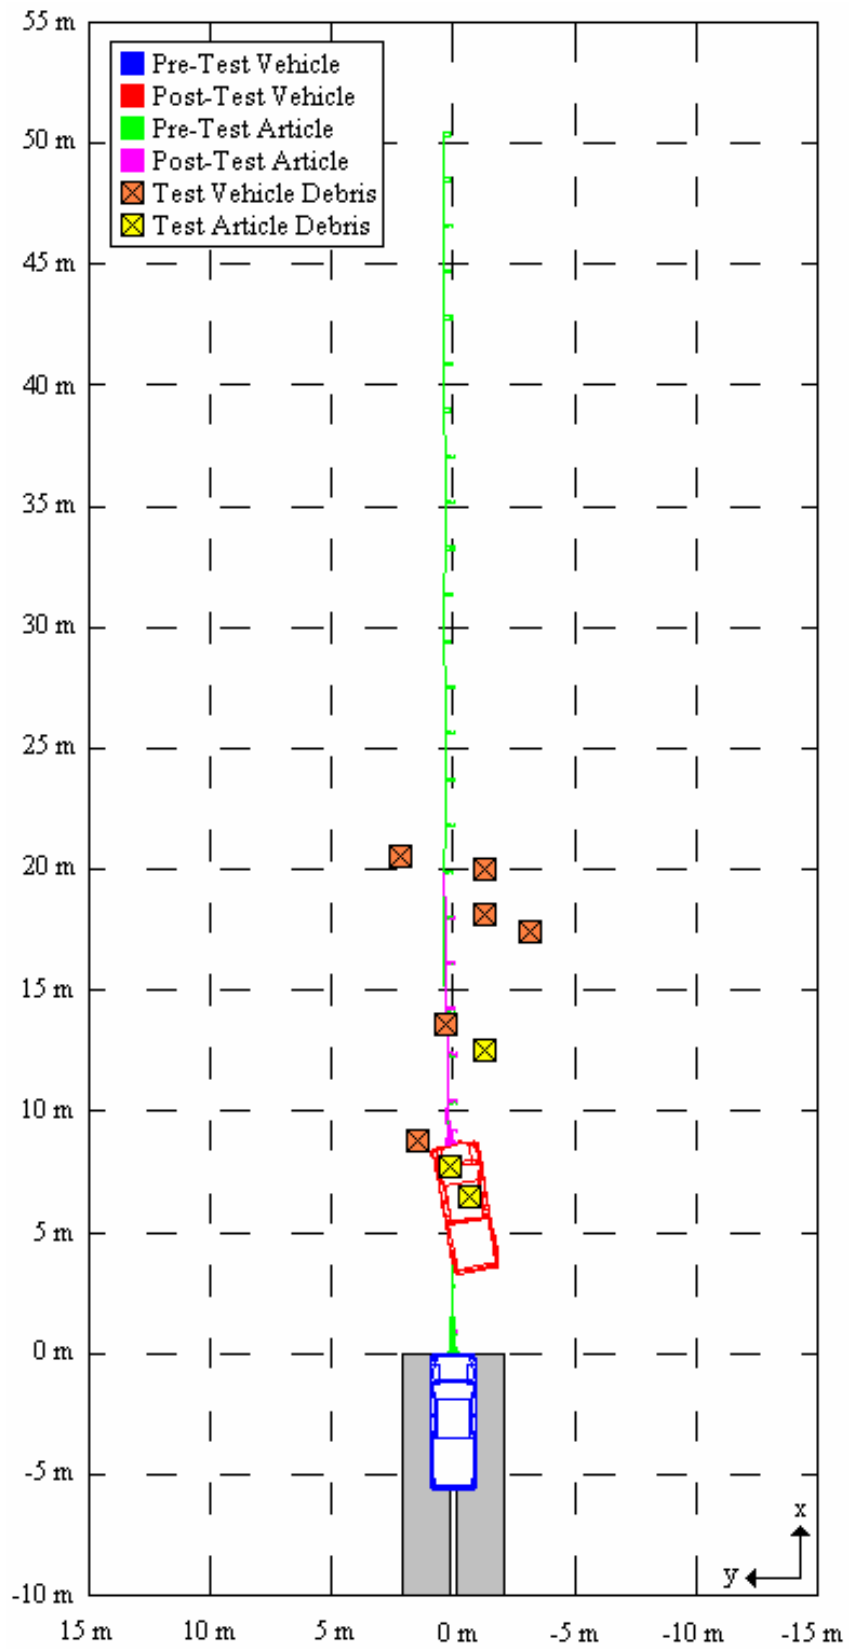
FIGURE 62. Overhead Illustration

For this test, the ET-Plus 50' (15.24 m) System was adjoined to the end of a 34.2 m (112.3 ft.) length of guardrail, measured from post 9 to post 27. The adjoining guardrail included a 3.7 m (12.2 ft.) long trailing end terminal treatment, measured from post 25 to post 27. The terminal's adjoining barrier consisted of seventeen (17) 1.8 m (6.0 ft.) long W6 x 8.5 standard I-beam line posts, one (1) 8" x 6" wood post with a soil plate and steel foundation tube, four (4) 7.6 m (25.0 ft.) long 12 Ga W-beam rail panels, one (1) 3.8 m (12.5 ft.) long 12 Ga W-beam rail panel, and one (1) cable anchor assembly. 191 mm (7.5 in.) plastic offset blocks were on all posts except the last wooden post. All of the posts, rails, and plastic offset blocks were fastened in the same manner as the SYTP posts of the ET-Plus Terminal.
